TECHNICAL REPORT 4842

**DYNAMIC ANALYSIS OF THE SAFING AND ARMING
SYSTEM FOR PD FUZE M572E2**

EDWIN B. ENTIN

**PICATINNY ARSENAL
DOVER, NEW JERSEY**

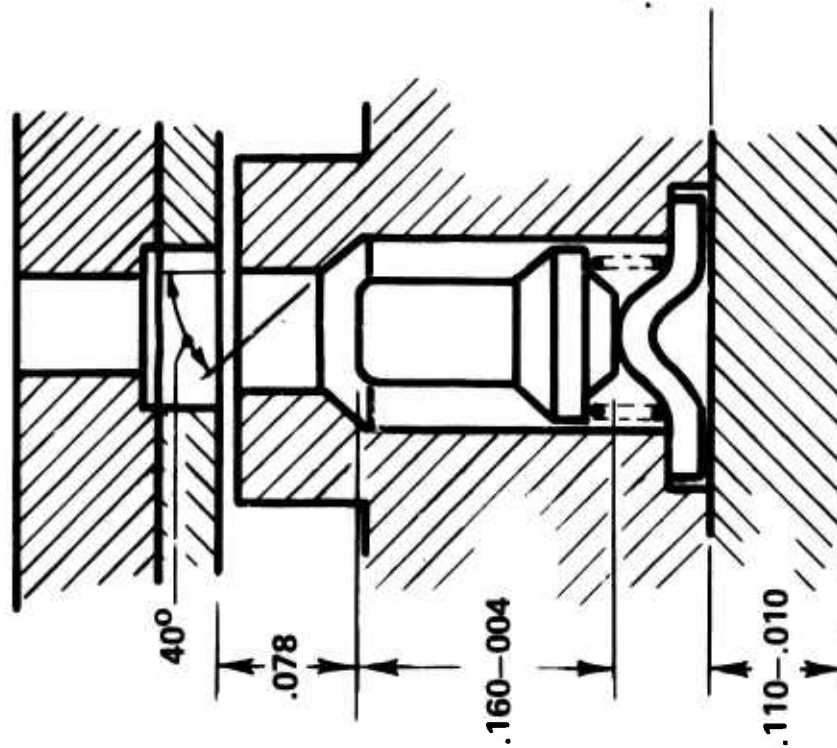
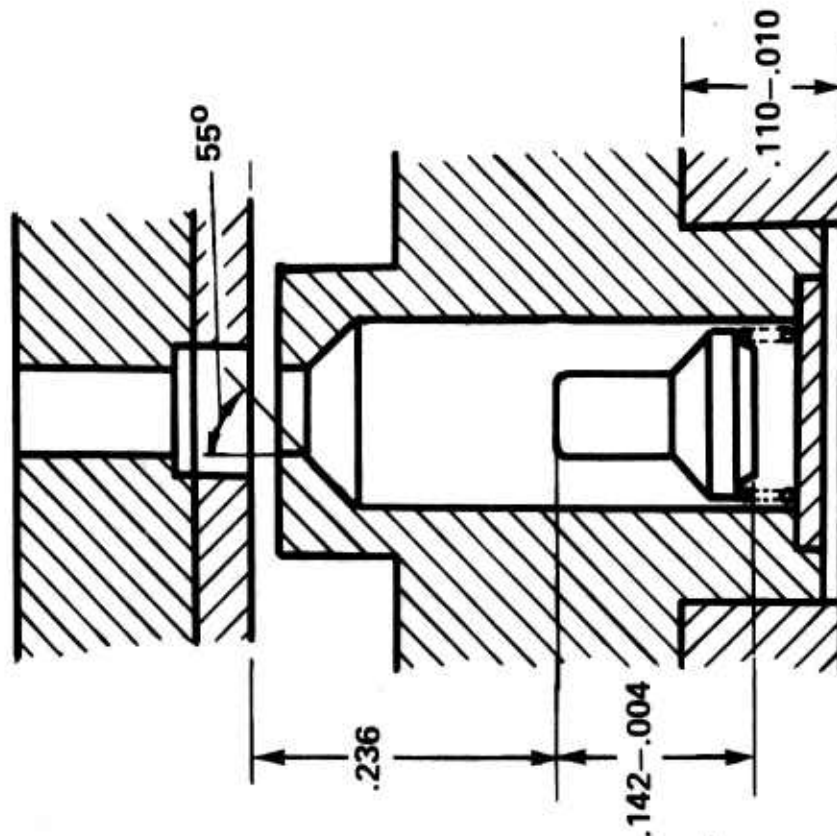
Fig 4 Setback pin and cavity area

1972 ET/ST DESIGN
 (.078 DISPLACEMENT)
 33 G SETBACK SPRING
 STEEL SETBACK PIN

1973 ET/ST DESIGN
 (.236 DISPLACEMENT)
 20 G SETBACK SPRING
 TUNGSTEN SETBACK PIN

1. A setback pin made from a heavier material (tungsten) and featuring a larger base diameter with a corresponding lower center of gravity, was substituted for the original steel setback pin. The heavier material permits the use of a more readily producible setback spring. The center of gravity was lowered to increase the centrifugal holding force of the setback pin toward the sidewall and avoid rapid tilting motion of the pin whenever the shell might experience sudden lateral displacements down bore.

5. The aluminum-dimple configuration retainer plate at the cavity base was removed and replaced by a soft-aluminum flat disc to further dampen any axial bounce of the setback pin.

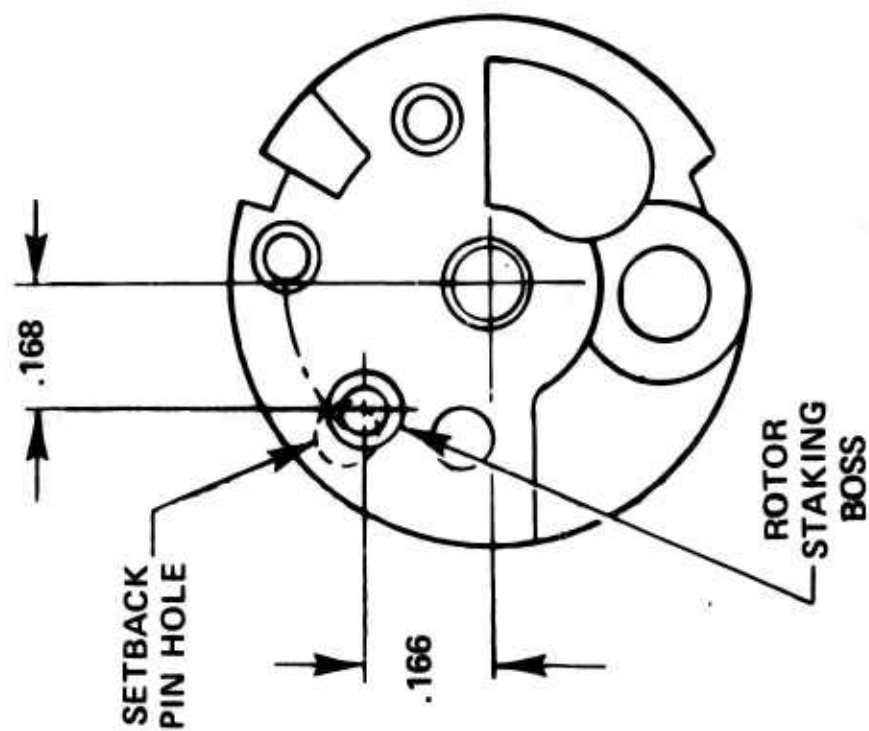
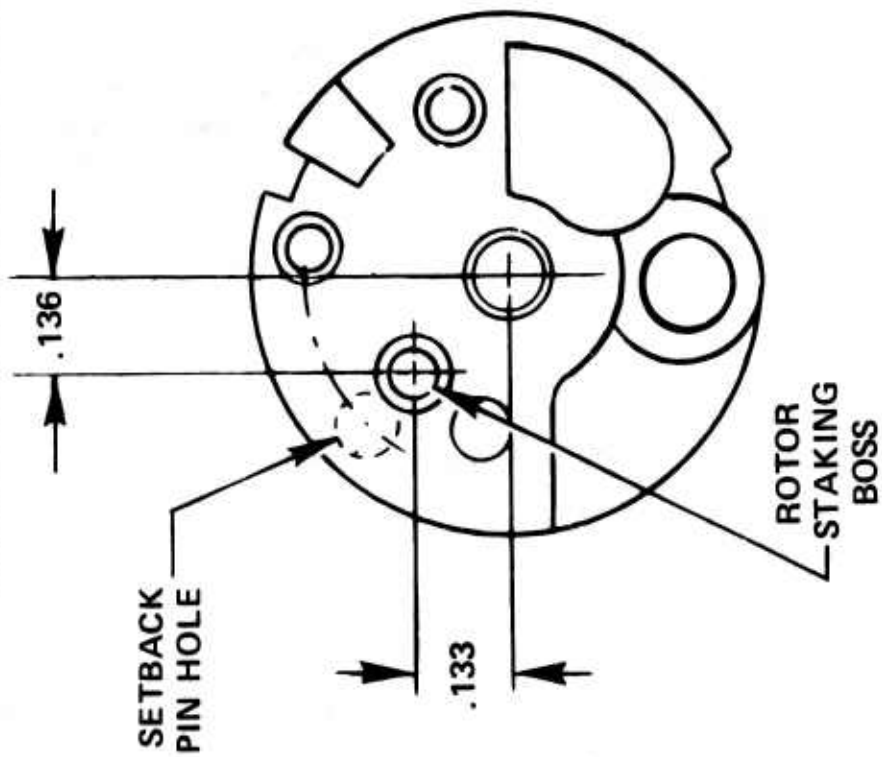
Fig 5 Relocated rotor gear stake

1972 ET/ST ROTOR BODY

1973 ET/ST ROTOR BODY

6. The hole and staking for the rivet pin, which holds the rotor gear to the rotor, were relocated inboard to prevent interference of the rotor and setback pin.

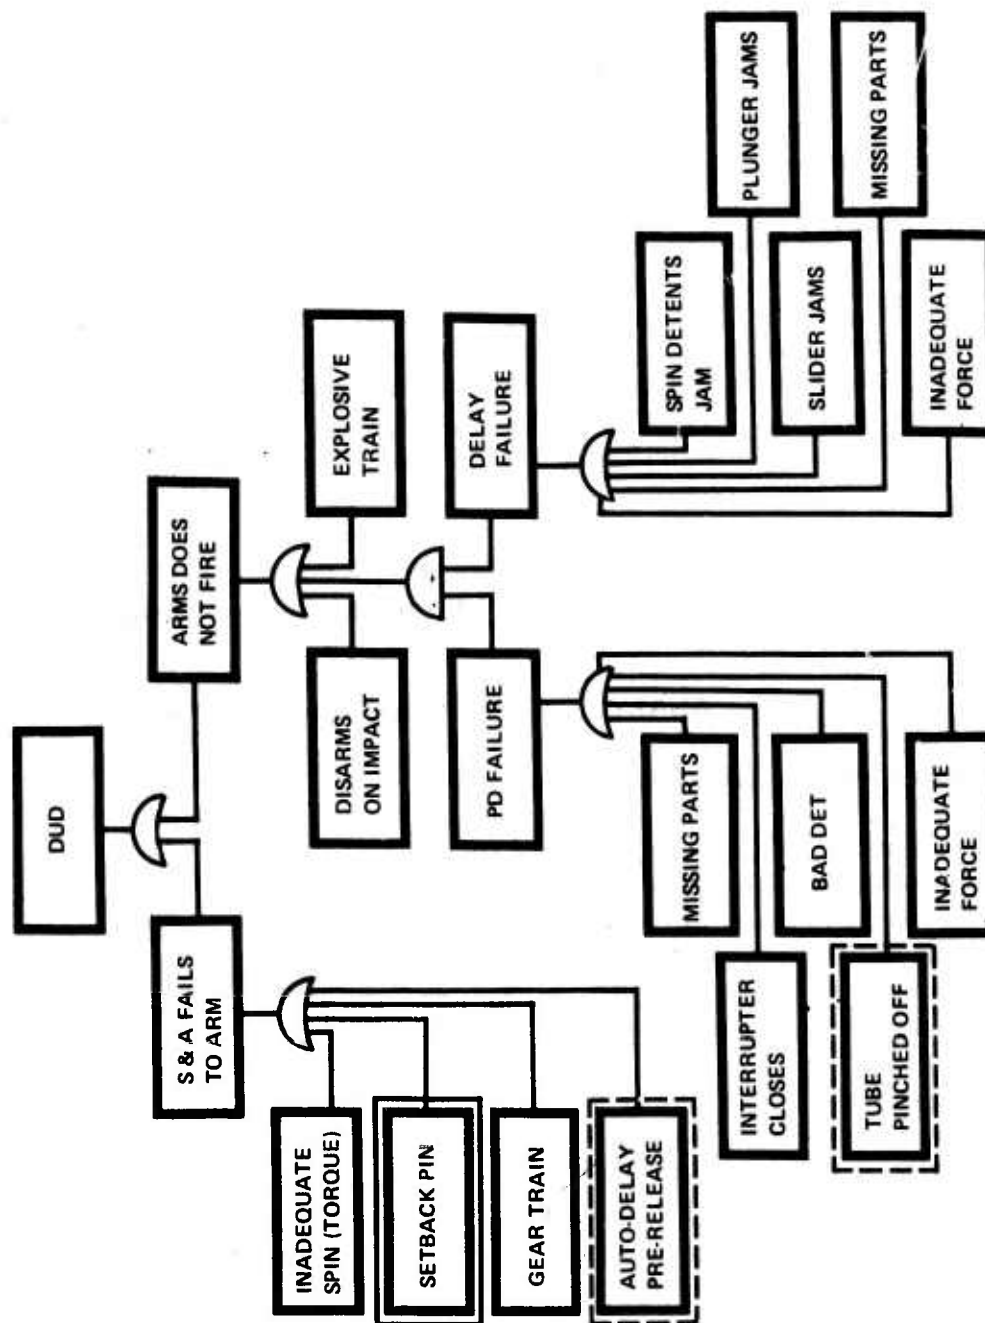
Fig 8 Failure diagram

The failure diagram used in the preliminary analysis which identified the failure causes is shown in Figure 8. The primary failure mode (setback-pin failures) applicable to the S&A failures in low-zone howitzers, addressed by this report, is enclosed by a solid line. The two secondary failure modes, not covered in this report, are enclosed by broken lines.

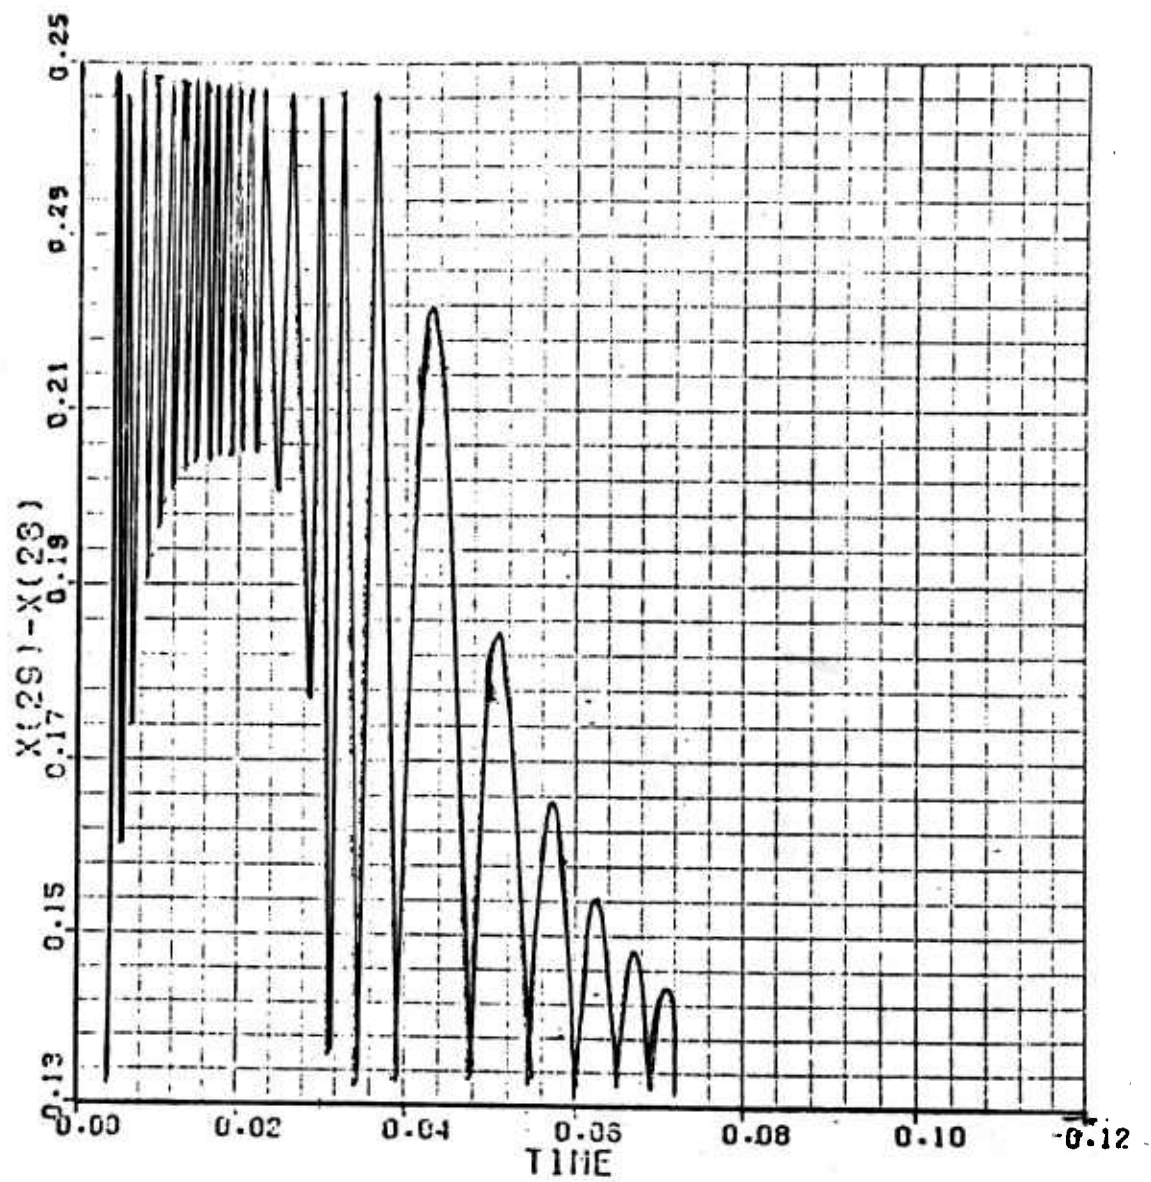
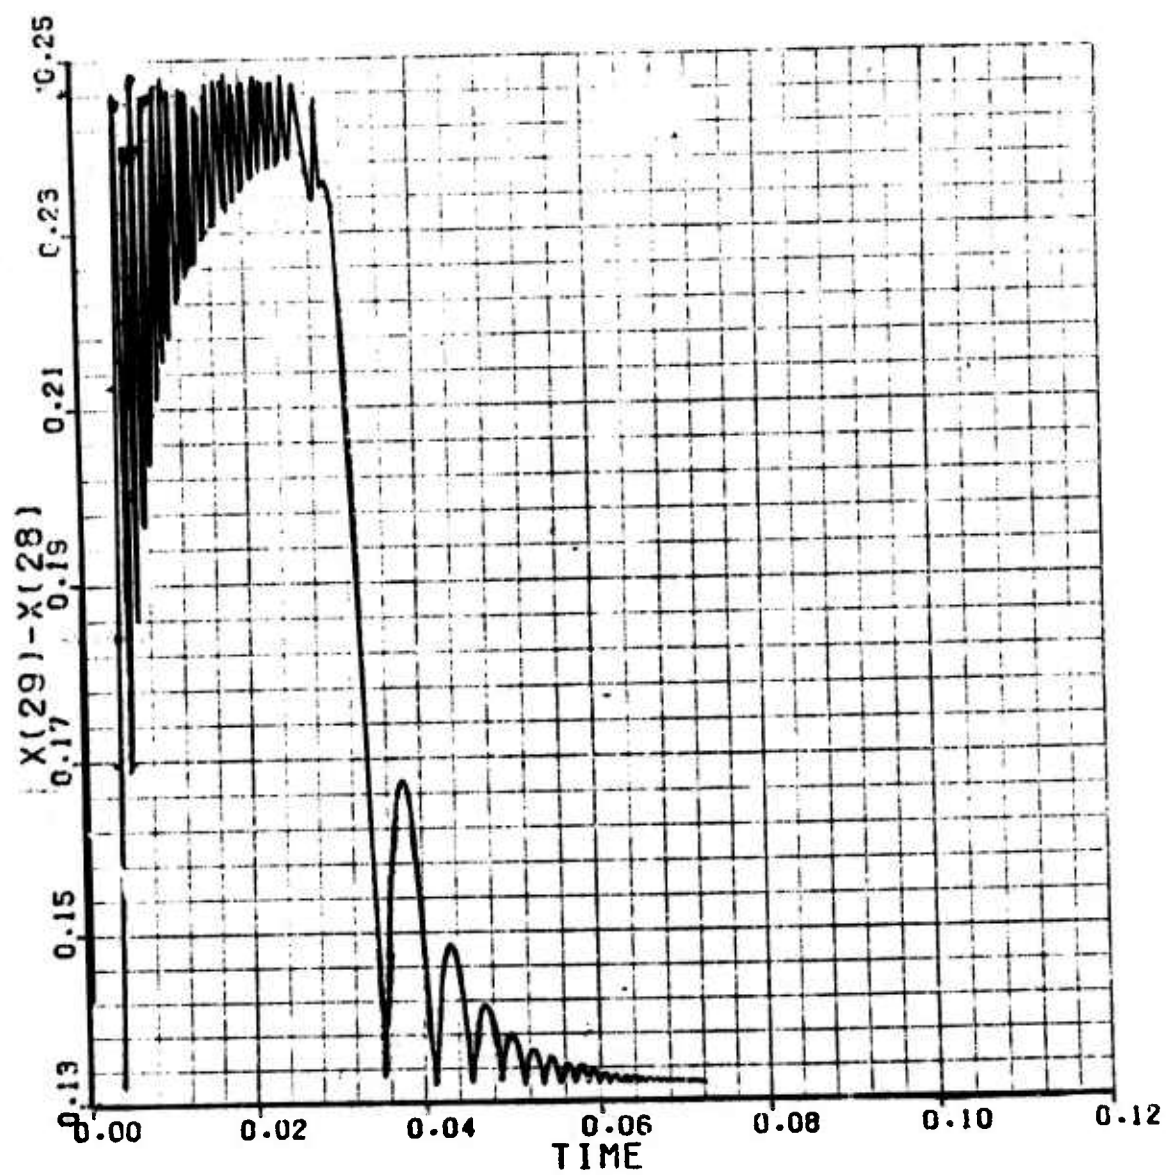
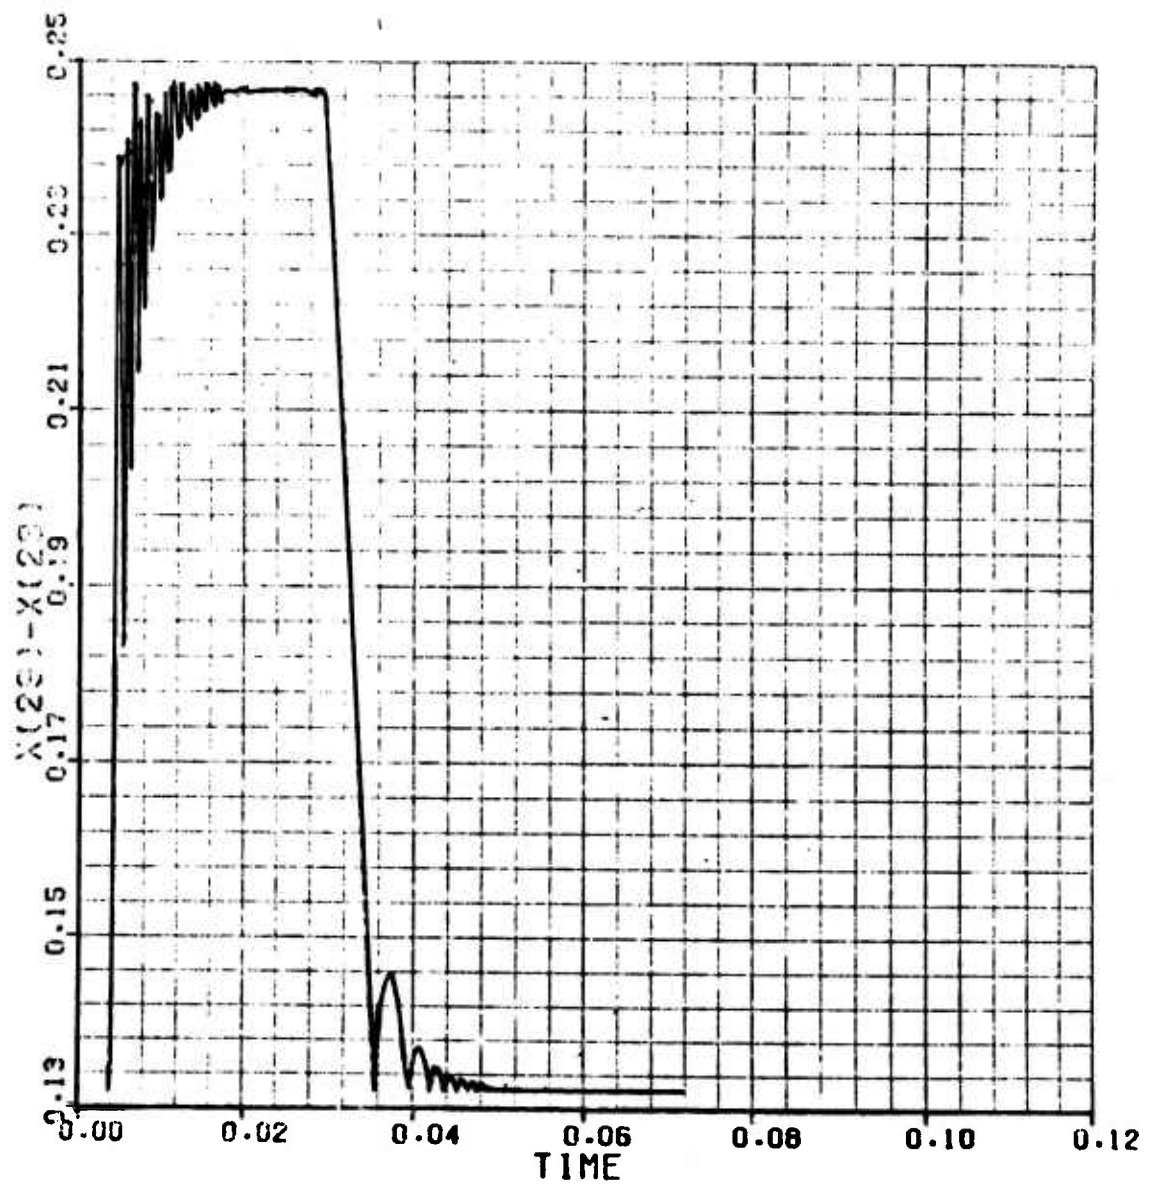
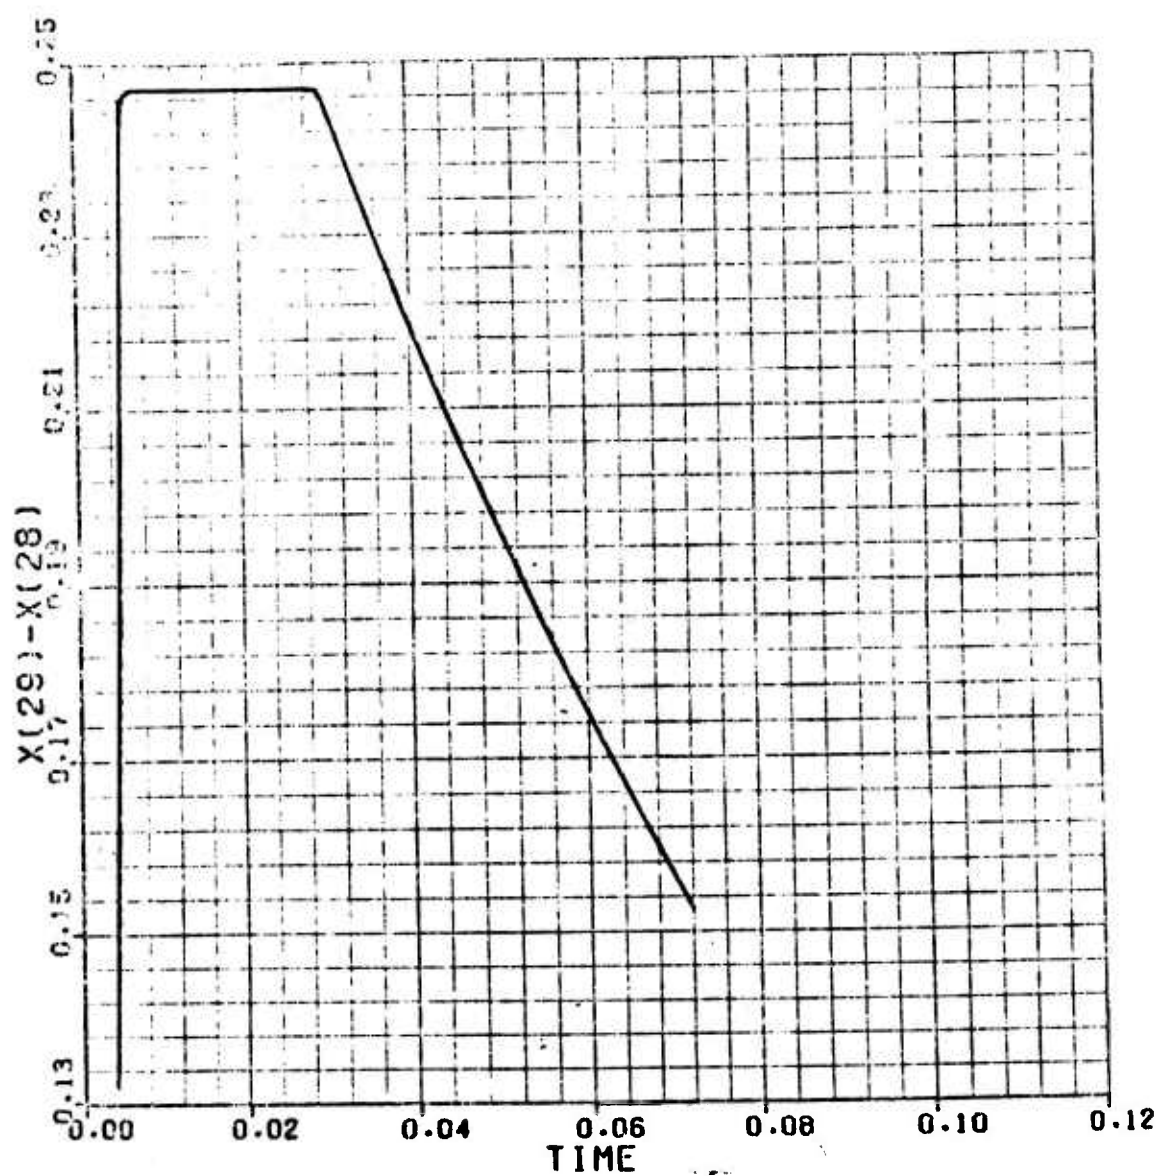
Five runs were made with increased damping for the setback-spring motion between boundaries, while keeping boundary collisions with zero damping (perfectly elastic). This was recognized to be a very conservative assumption. The rationale involved searching for a positive fix to the problem which would effect a solution under the worst conditions. (These conditions included perfectly elastic rebounding and continuous lateral alignment.) Relative damping ratios of 25-, 50-, 100-, 1,000-, and 10,000- percent critical were investigated. The time for initial re-seating ranged from almost immediately after muzzle exit for 25 percent critical, to about five milliseconds for 100 percent, to about 54 milliseconds for 1,000 percent. One of the pertinent results demonstrated by these solutions is that if the pin comes to a position of alignment for any of the reasons discussed above, even without rebounding motion, the setback-pin spring itself can cause reseating shortly after muzzle exit. The 25-, 50-, 100-, and 1,000-percent critical conditions are illustrated in Figures 14, 15, 16, and 17, respectively, where muzzle exit occurs at 29.5 millisecond (0.0295 time). The ordinate "0.25" represents pin bottoming, and the ordinate "0.13" represents seating of the pin in the rotor. For pin motion unrestrained by friction forces along the cavity wall, it was apparent that significant dash-pot type damping is required to guarantee successful operation after the shell leaves the muzzle.

Fig 14 Setback-pin response $\zeta = 25$ percent

Fig 15 Setback-pin response $\zeta = 50$ percent

Fig 16 Setback-pin response $\zeta = 100$ percent

Fig 17 Setback-pin response $\zeta = 1,000$ percent

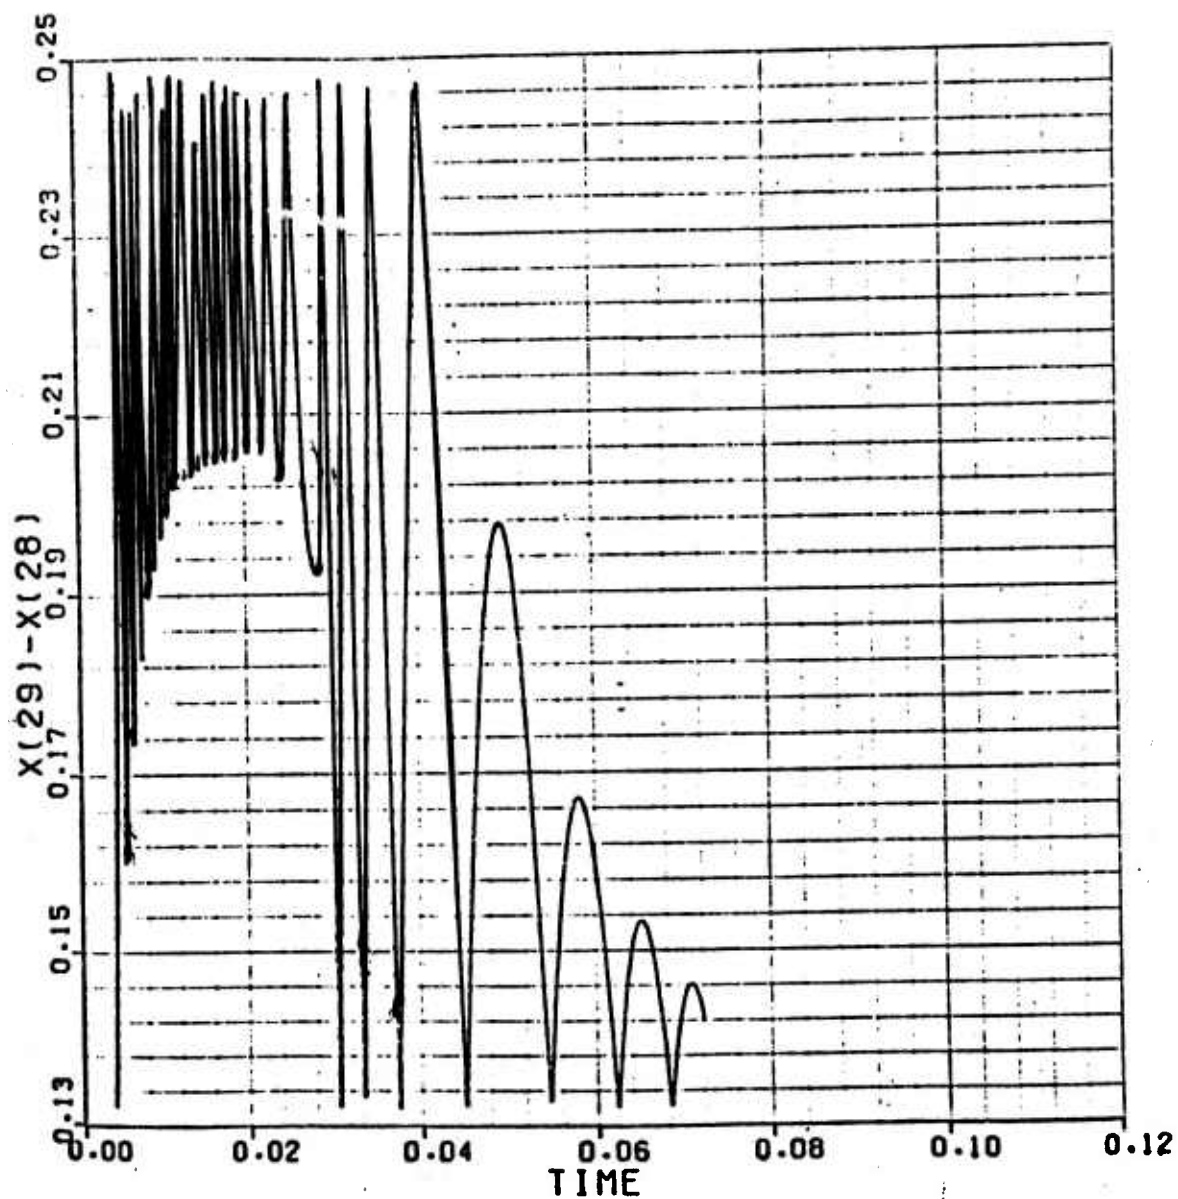
Fig 18 Setback-pin response $\zeta = 25$ percent, $k \rightarrow 20$ g's

Two setback-pin springs, 20G and 5G, were investigated as possible replacements for the then-current 36G spring to determine the effect of setback-spring stiffness. The setback pin has its initial reseating after about a millisecond for the 20G setback-pin spring (Fig 18) and eight milliseconds for the 5G setback-pin spring. The damping utilized in this investigation was 25-percent critical relative to the 36G system. The reseating delay is associated primarily with the higher relative damping and the effects of the velocity shocks; although the lower stiffness helped, its effect was not very significant.

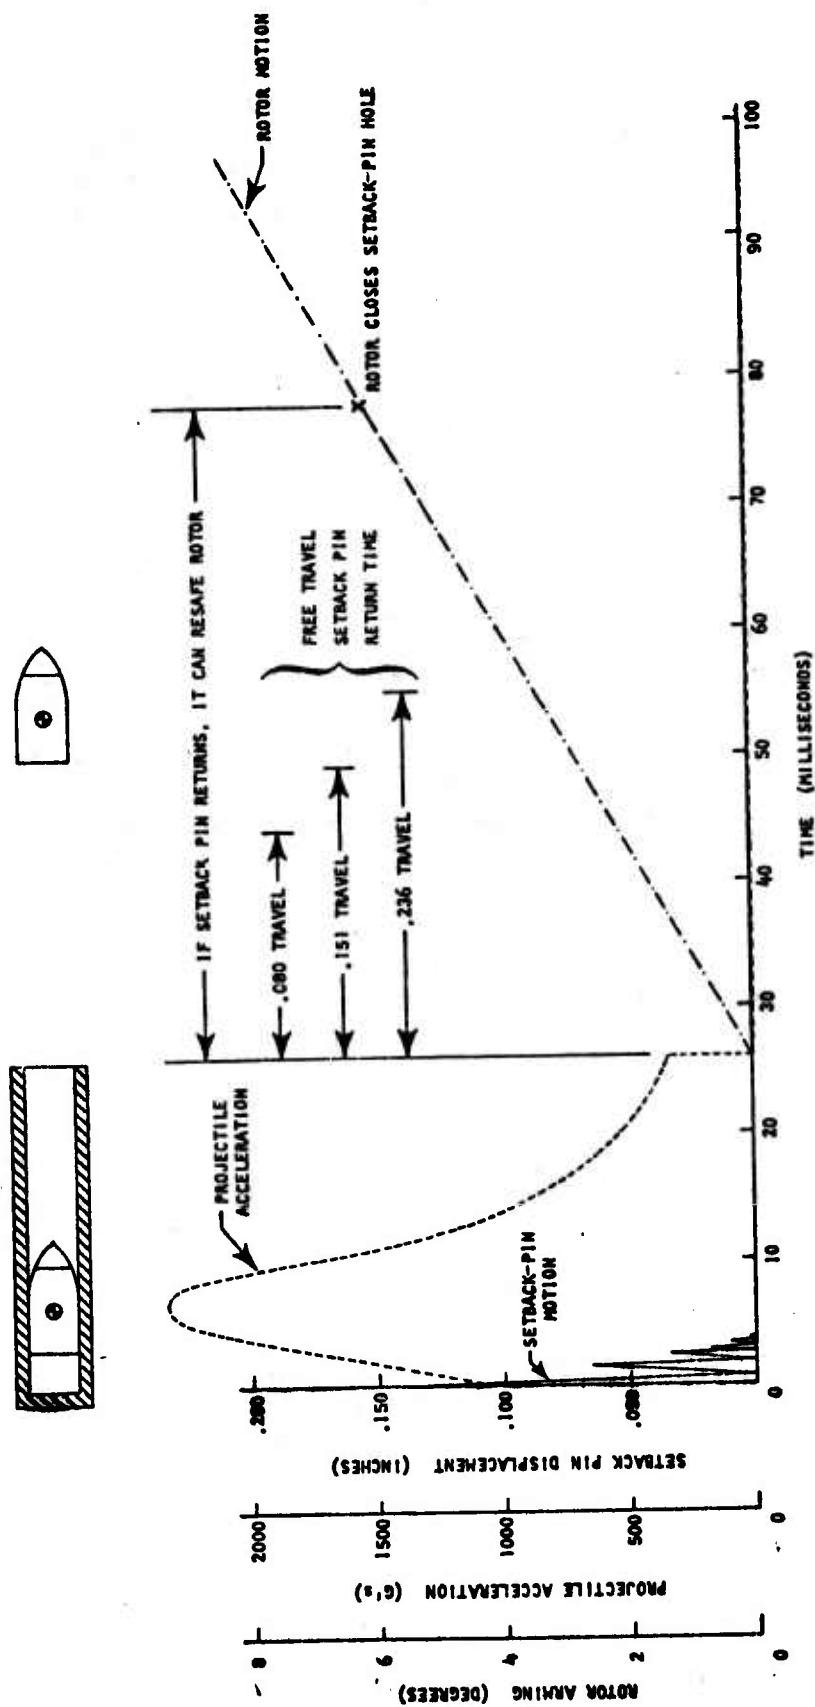
Fig 19 Low G setback-pin response to 8-inch zone 1 firing

Experimental data on rotor response indicates that the position of the rotor is such that pin reinsertion could occur up to 80 milliseconds after firing (Fig 19). Thus, the dynamic behavior of the pin was studied over this period of time and the assumption accepted that, should the pin move forward to a point where its tip crossed the lower plane of the rotor, the condition of failure would be achieved.
